NATIONAL TRANSPORTATION SAFETY BOARD
OFFICE OF AVIATION SAFETY
WASHINGTON, DC 20594

POWERPLANTS GROUP FACTUAL REPORT

NTSB ID No. DCA05MA003

Location: Jefferson City, Missouri
Date: October 14, 2004
Time: 10:13 pm CDT
Aircraft: Bombardier CRJ-200, Reg. No. N8396A, Northwest Airlines
#3701 Operated by Pinnacle (REXA)

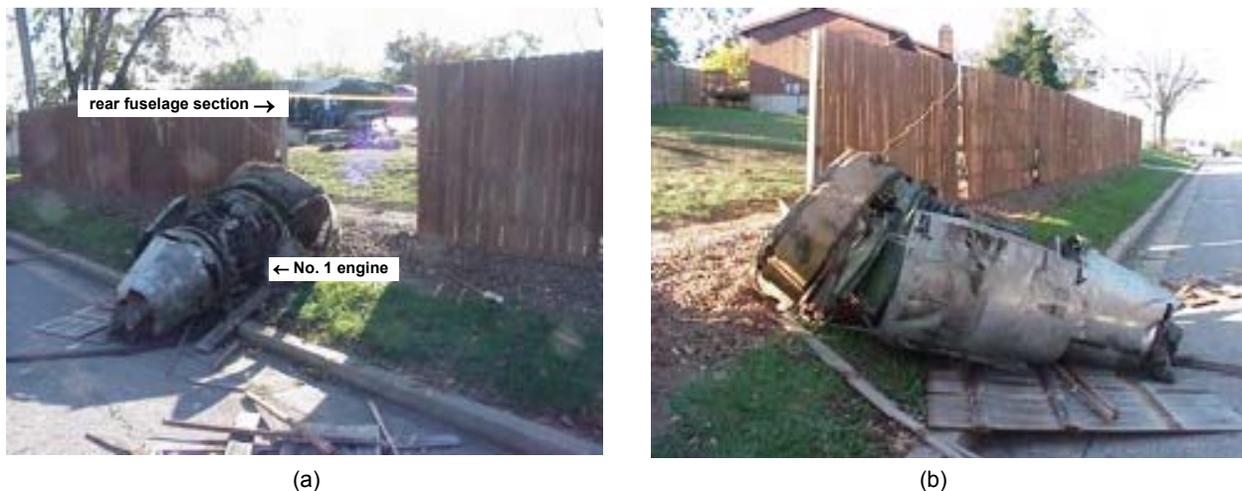
The No. 1 engine was found lying on its right side⁵ on the east side of Hutton Lane, a residential street, approximately 25 yards from the airframe rear fuselage/tail section. (See Figure

1.)⁶ The engine was lying on top of fencing material that had broken away from a property line fence. An 18 inch long, 8 inch deep ground scar (divot) was observed about 10 feet from the forward end of the engine, on the east side of the fence line. Clay was found in the fan inlet, packed between the fan blades.⁷ There were no indications of engine uncontainment or fire damage. A visual inspection of the LPT through the tailpipe found no anomalies.

Figure 1. (a) Position of No. 1 engine relative to rear fuselage; (b) right side of No. 1 engine

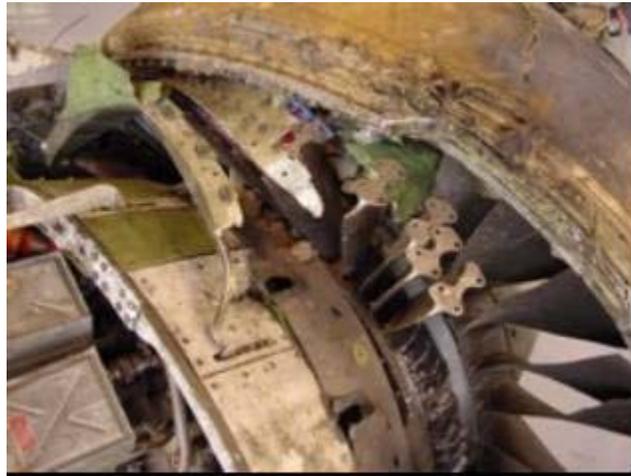
The fan containment case was ovalized and had displaced aftward between 10 and 12 o'clock; the aft fan case was separated aft of its forward flange in this area.⁸ There were deep airfoil-shaped gouges on the flow path surface of the fan blade containment casing between 2 o'clock and 3 o'clock, about 5 inches forward of the normal blade tip running plane. These gouges were consistent with the contour of the fan blade tips. Four gouges of lesser depth were found along the same circumferential plane, between 3 o'clock and 4 o'clock. An 18 inch x 8 inch area of the containment case Kevlar material was damaged at 9 o'clock, with one 3/4 inch-diameter penetration through the Kevlar layers, and tearing of the outer Kevlar layers in several other locations. A large amount of clay⁹ was packed in the spaces between fan blades 13 to 21, and loosely packed in other areas of the module.¹⁰

A section of the aft fan case was missing from 12 to 4 o'clock; this section included the 2 o'clock forward engine mount. The case was torn between 7 and 12 o'clock, and additional sections were separated, exposing stator vanes or empty stator vane slots. At least ten stator vanes were observed separated at their inner band (root) attachment; these vanes remained attached at their outer band. Stator vanes protruded from the case from just beneath the upper forward engine mount, from 11 to 7 o'clock, and the fan case was displaced outboard in this area. (See Figure 2.)

The spinner was severely damaged. The fan rotor was seized. An arc of eight blades (fan blades 10, 9, 8, 7, 6, 5, 4, and 3) was bent opposite to the direction of rotation, where the fan

blade containment case was crushed inward between 2 o'clock and 4 o'clock. An arc of four blades (fan blades 19, 18, 17, 16) was bent in the direction of rotation where the fan blade containment case was crushed inward between 8 and 9 o'clock. The tips of fan blades 20 and 21 were embedded in the fan containment case, and fan blade 20 had a chordwise trailing edge (TE) tear at $\frac{3}{4}$ span. The outer 25 percent of the fan blade 22 airfoil was missing. The tip of fan blade 23 exhibited leading edge (LE) hard body impact damage and a small TE tear at $\frac{3}{4}$ span.

Figure 2. No. 1 engine fan module damage

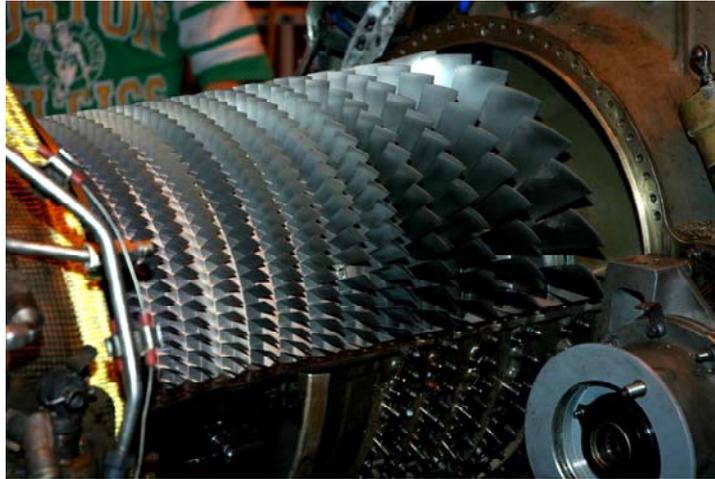
Figure 3. No. 1 engine compressor rotor

The compressor rotor was in good condition. (See Figure 3.) Very light (typical in-service) rotor blade tip rubs were noted on stages 2, 6, 8, 12, and 13. The stage 1 and stage 2 inner shroud seals were intact, with typical in-service seal wear-in grooves.¹⁵ A small amount of leaves and dirt was found in the first three stages of the compressor gas path. A single fragment of outlet guide vane spacer was found just forward of the stage 1 vanes.

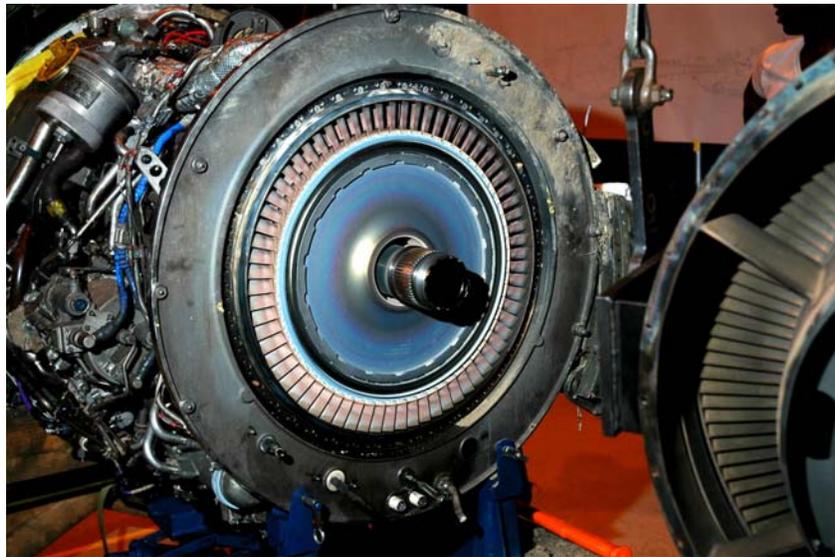
All of the HPT airfoils were in good condition. (See Figure 4.)

The HPT stage 1 shroud segments had light rubs at 11 o'clock and were heavily rubbed and gouged between 4 and 5 o'clock, and from 6 to 8 o'clock. There was surface corrosion on all of the segments, including areas with rub indications.

Figure 4. No. 1 engine turbine modules

Minor tip oxidation was present on the HPT stage 1 blade tips, and there was no evidence of heavy tip rub. The stage 2 blades were in typical in-service condition, with light rub indications at the blade tips.¹⁸

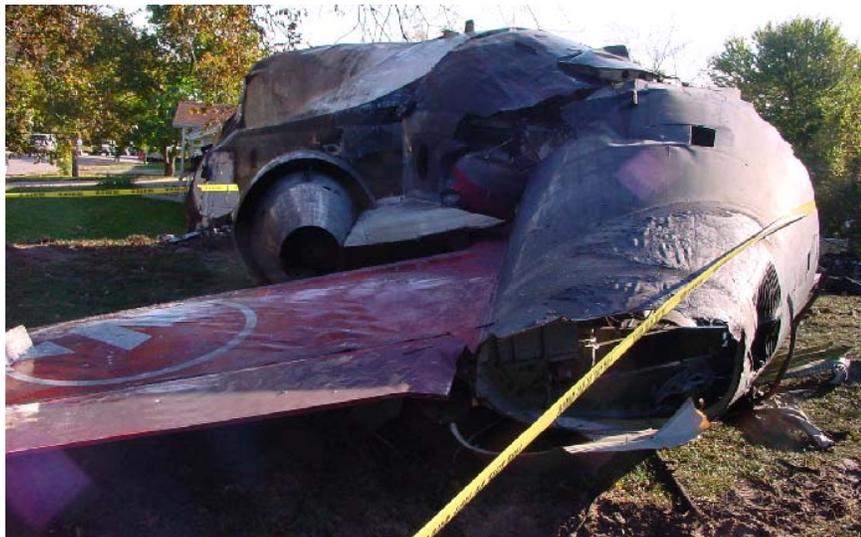
The No. 2 engine was found still attached to the fuselage pylon. This section of the fuselage was inverted, and the engine's nose cowl, access cowl, thrust reverser and transition cowl were resting on the ground. (See Figure 5.)

Figure 5. Attitude of rear fuselage, with No. 2 engine attached at pylon

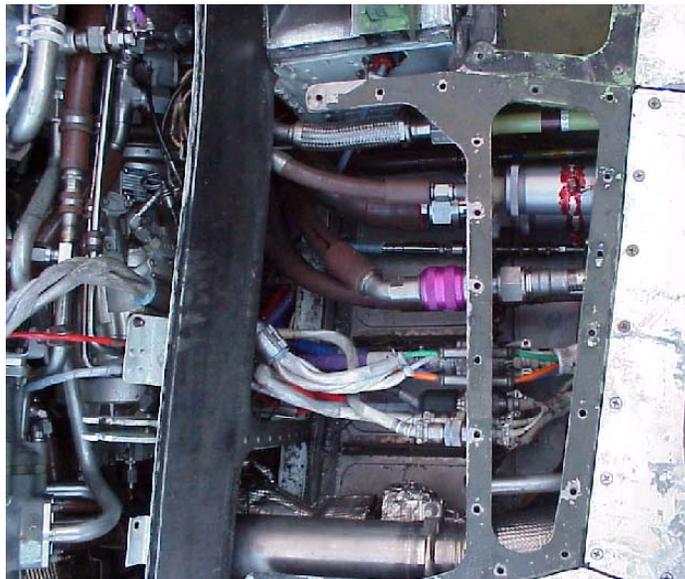
Overall, the core engine appeared in good condition. The pylon mounting structure was undamaged, and the engine-to-ylon connections were disconnected using standard tools. (See Figure 6.)

Figure 6. Condition of No. 2 engine pylon

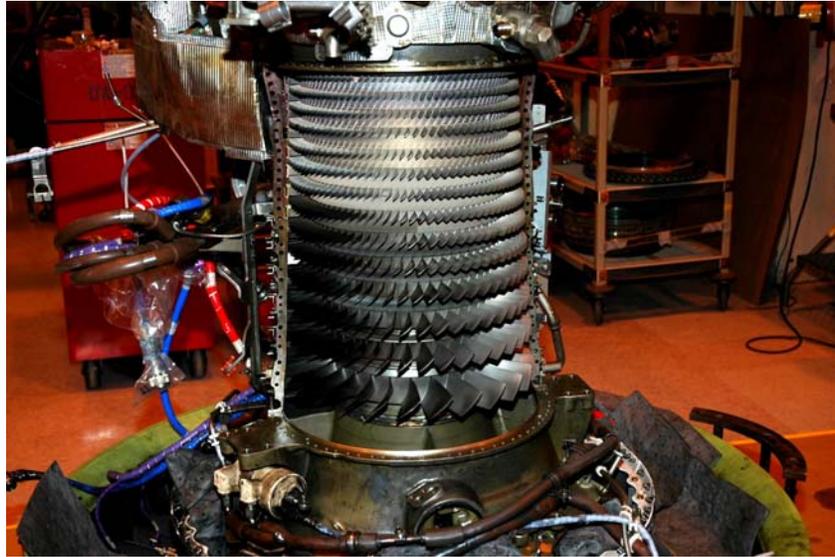
The compressor rotor was generally in good condition. (See Figure 7.) A small amount of wood, dirt, and leaves were found in the first four stages of the gas path when the lower compressor case half was removed. Very light (normal operational) rotor blade tip rubs were noted on the stage 11 and stage 13 blades. The rotor moved freely while in both vertical and horizontal positions.²⁵

Figure 7. Compressor rotor, No. 2 engine

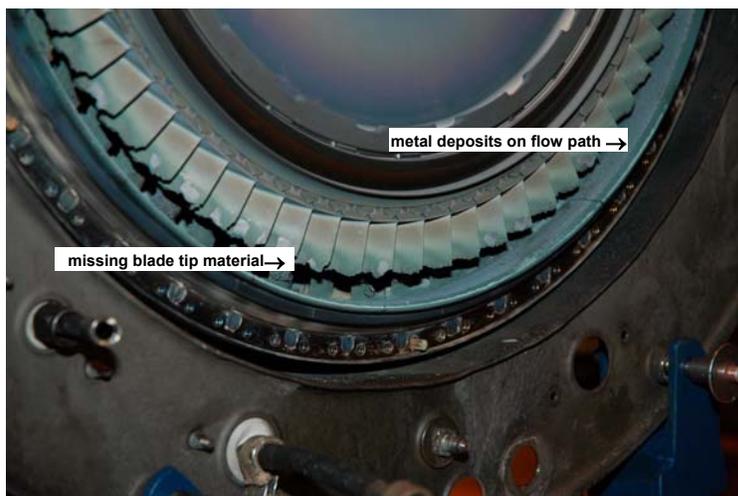
The stage 1 blades exhibited heat distress, with missing material tapering back from the LE tips to the 5th cooling slot in the TE's, approximately midspan. The stage 2 blades showed heat distress. All airfoil material above 60 percent span was missing. A cursory metallurgical evaluation of the HPT blades identified lifting and spalling of the coating on the airfoils, indicative of incipient melting at the coating diffusion zone/base metal interface.²⁷ (See Figure 8.)

Figure 8. No. 2 engine HPT damage

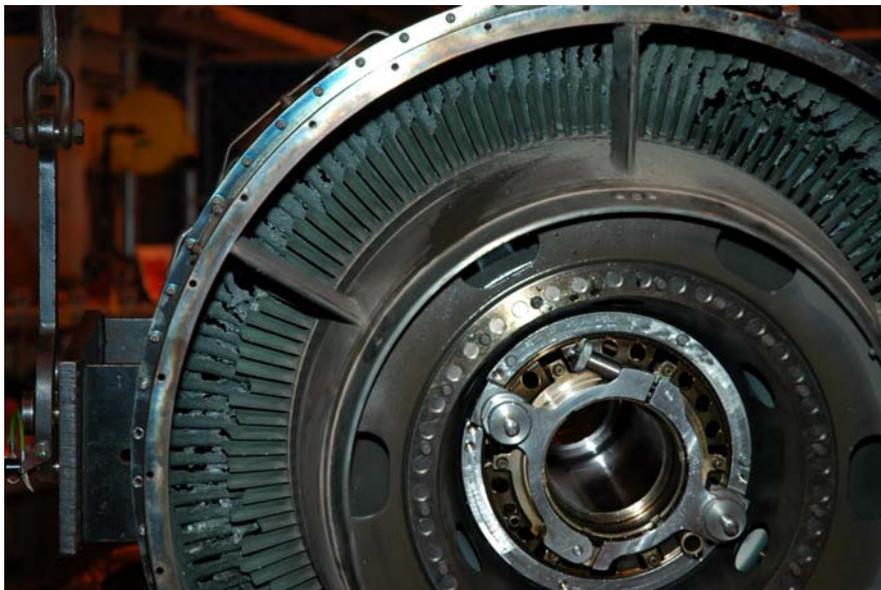
There were metal deposits on the transition duct flow path surface, and on the thermocouple probes. All thermocouple probes were intact. All stage 3 nozzle vanes exhibited areas of bulging and waviness and the TE material of most of the vanes was missing at about 70 percent span.

Debris was lodged between the stage 3 nozzle and the stage 3 rotor at 3, 6, and 9 o'clock. A large amount of metallic debris, including pieces identifiable as blade and shroud fragments, had accumulated along the entire LPT flow path at 6 o'clock. The stage 4, 5, and 6 stator vanes were missing 80 to 90 percent of their airfoil length between 12 and 2 o'clock. The remaining portions of the vanes were heat distressed. Material appearing to be re-solidified metal was deposited on the stage 6 nozzle at 3 and 9 o'clock. The stage 6 shroud was heavily scored over 360° including areas of sufficient depth to be through the honeycomb and into the backing material of the shroud. All LPT blades exhibited uniform airfoil loss per the percentages listed in Table 3. With the exception of metal splatter found deposited on each of the struts, the exhaust frame appeared in typical in-service condition.

Figure 9. No. 2 engine LPT damage

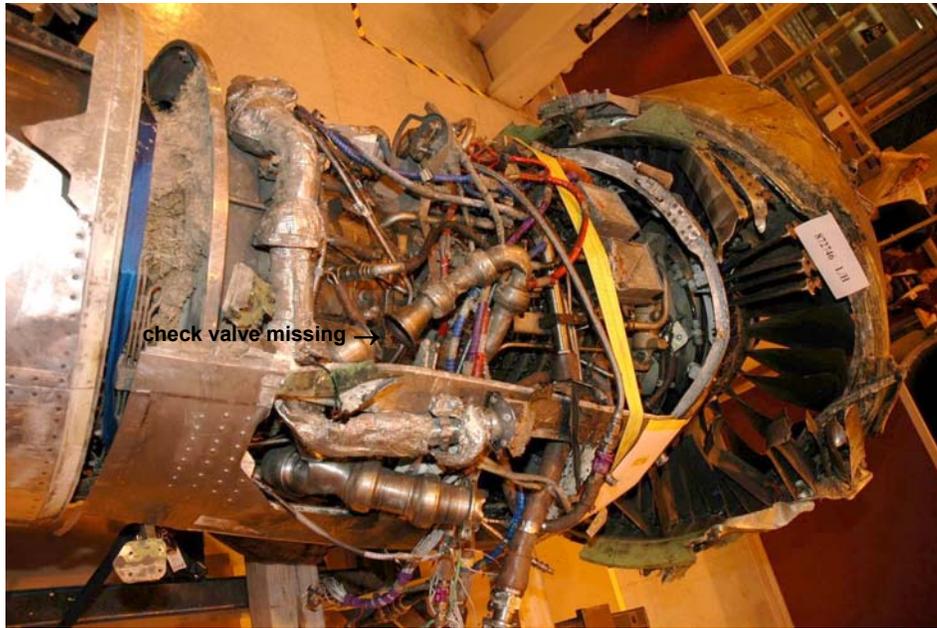
Figure 10. Damaged No. 1 engine stage 10 ducting

The No. 1 engine 10th stage bleed pipe was crushed and bent at the top elbow, and twisted and crushed at the Y-joint below the check valve. (See Figure 10.) The 10th stage bleed air check valve housing had separated, revealing the valve mechanism. (See Figure 11.) The exposed valve was moved within its housing, and opened and closed freely.³¹ The mount supporting the 14th stage bleed pipe at 2 o'clock was flattened (spread open); the insulation was missing from the pipe at this location, but the pipe was not distorted; the pipe was crushed at its transition through the bifurcation unit.

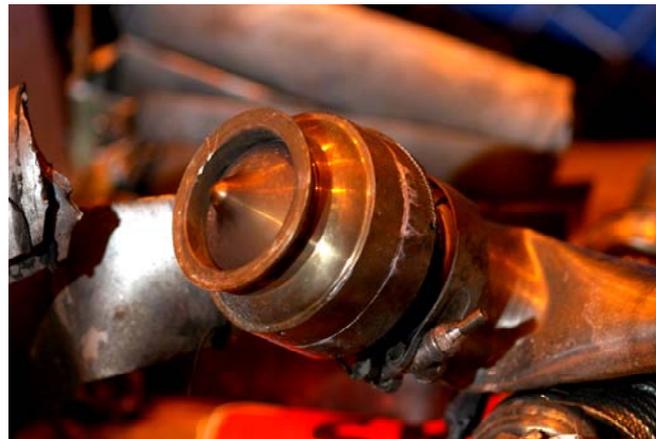
Figure 11. Stage 10 bleed air check valve

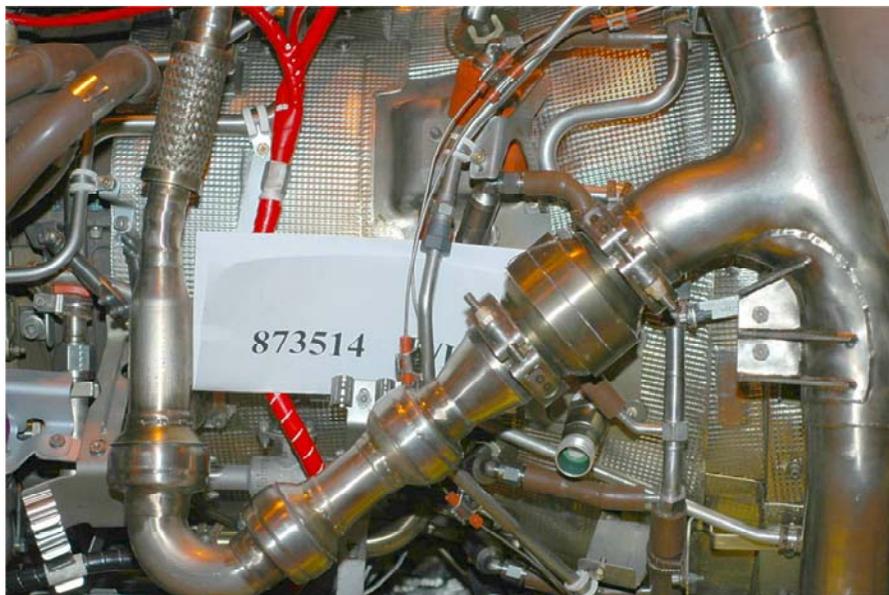
The No. 2 engine 10th and 14th stage piping were in good condition. (See Figure 12.) Visual inspection found no apparent cracks or damage, with the exception of one small dent on the 10th stage pipe at 12 o'clock. All joints were intact, with no evidence of leakage. The bleed pipes from the starter to the pylon connection were intact.

Figure 12. Intact No. 2 engine stage 10 ducting
